Bridge Street and State Street Intersections Safety Study

Safety Study
Prepared for: City of Struthers
September 2022

City of Struthers, Ohio
Mahoning County
Intersection: Bridge Street and Lowellville Road,
Bridge Street and State Street, and Bridge
Street and Terrace Street
Study Completion Date: September 2022
Consultant: Environmental Design Group

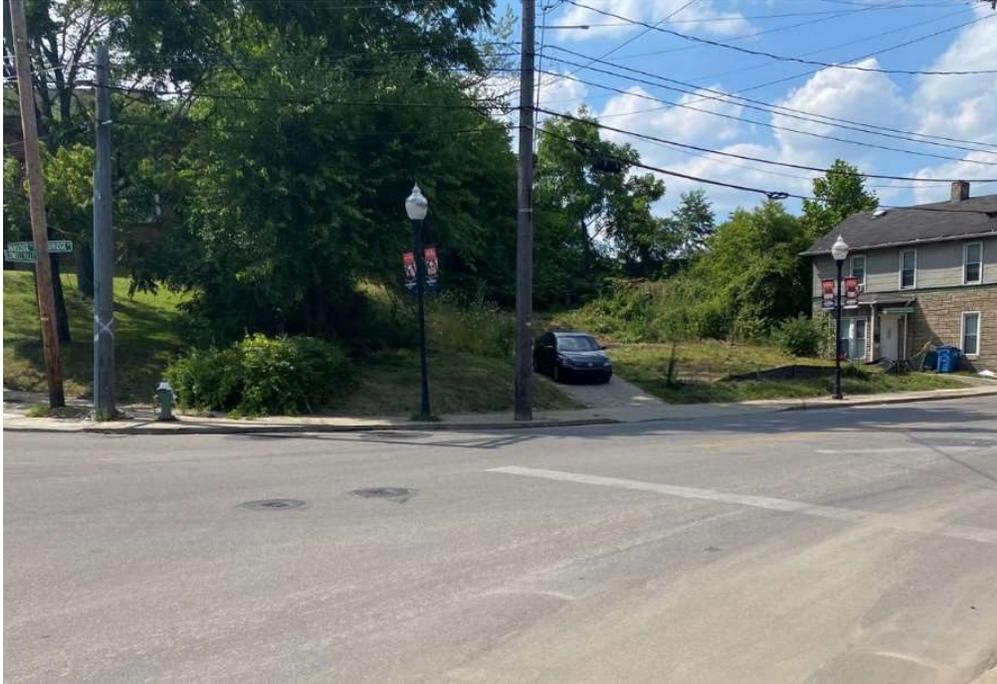
Figure 8 – Property at 173 South Bridge Street with house removed.

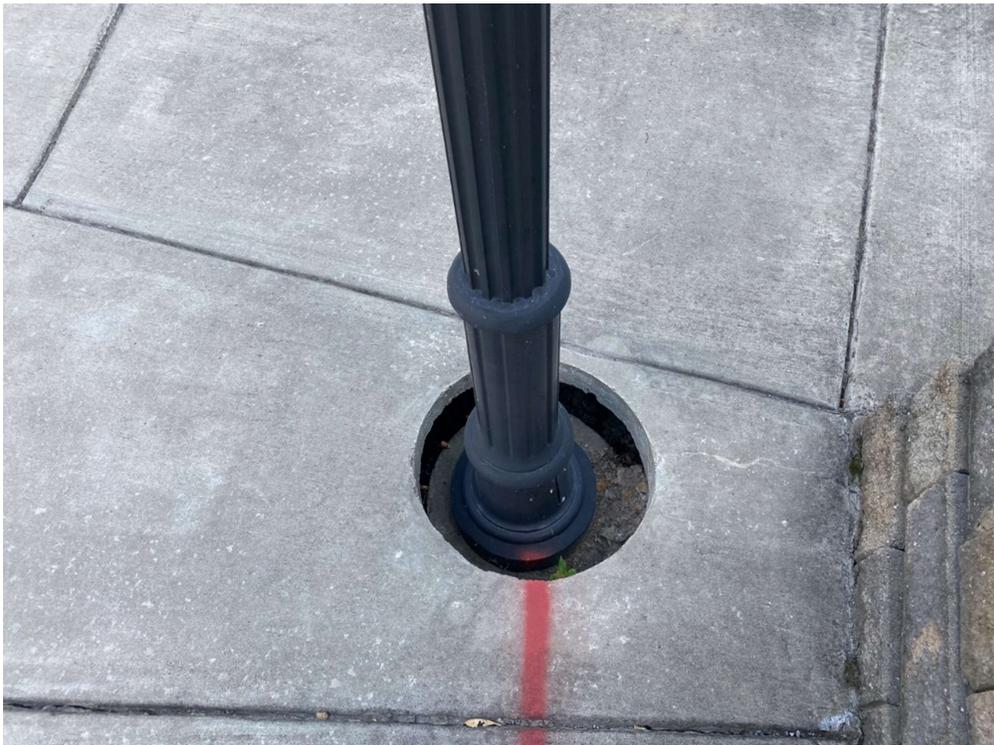
Figure 9 – Evident recent work with light poles.

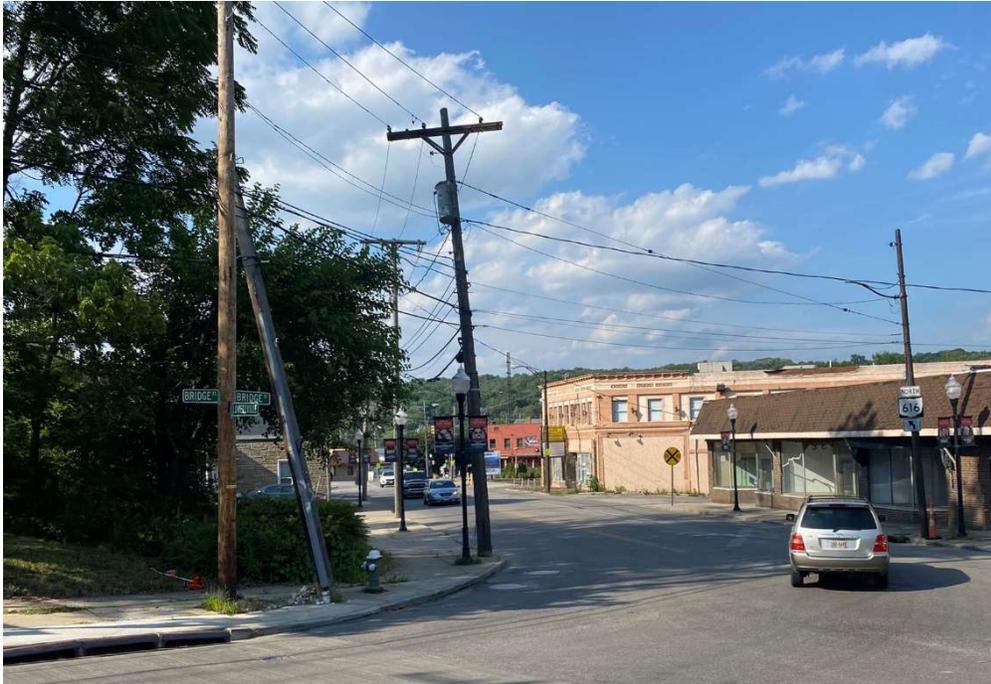
Figure 10 - Evident recent work with utility poles.

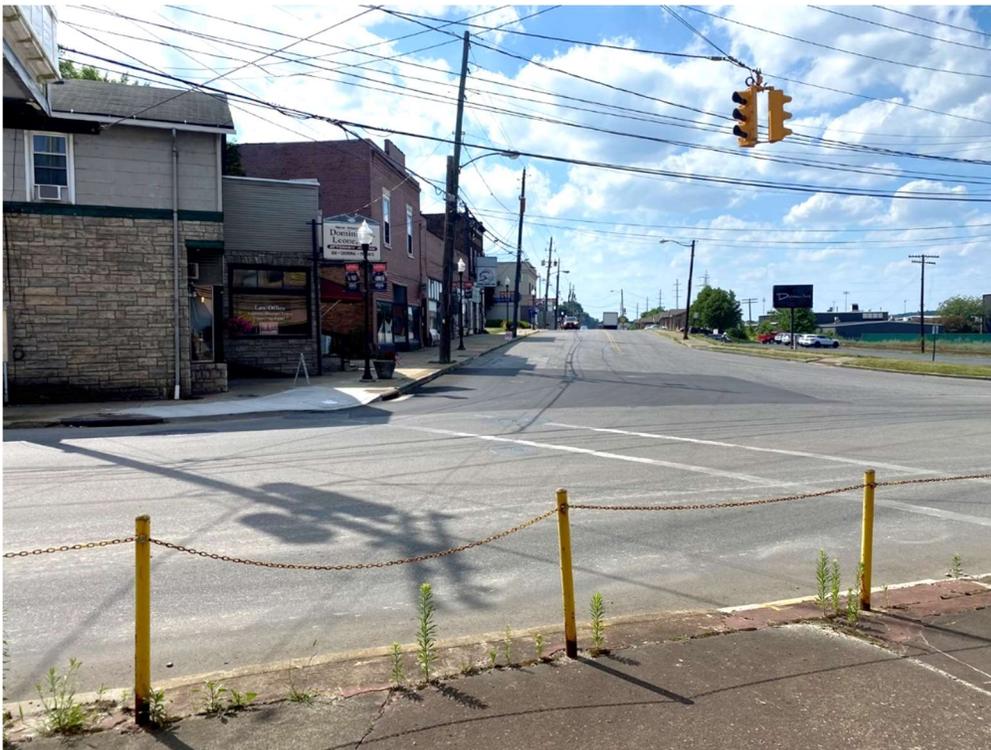
While sidewalk is available in most portions of the study area, some locations are incomplete, degraded, or non-existent. At the northwest corner of the State Street – South Bridge Street intersection, the sidewalk is discontinuous and placed around the brick-base, electronic City of Struthers sign. The sidewalk on the east side of Lowellville Road, South Bridge Street, is badly worn and cracked with earth and grass significantly overtaking the edge. There are curb ramps at some crossings but not all, and very few crosswalk markings on the pavement. A person using a wheelchair on the west side of South Bridge Street would be unable to cross without additional navigation on the roadway before reaching a location with a low enough curb to reach the sidewalk on the east side. At State Street and South Bridge Street, an old, rusted chain rail appears to be installed to direct pedestrians toward a driveway on the east side.

Figure 11 - Rusty chain rail directing pedestrians to driveway north of rail.

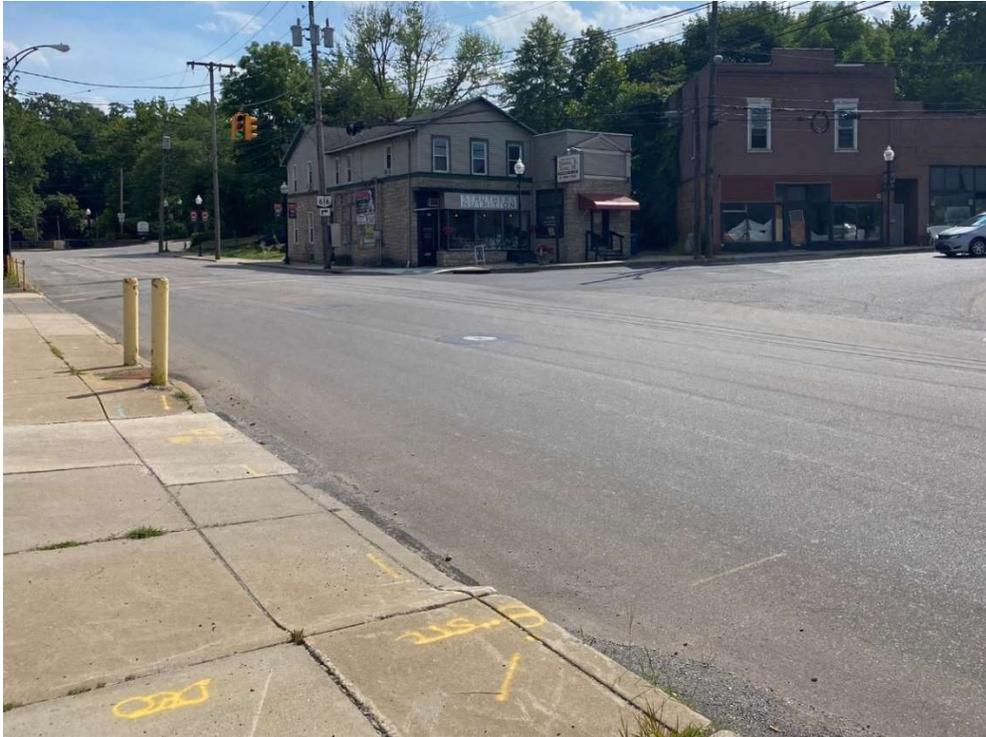
Figure 12 - Yellow bollards at catch basin inlet.

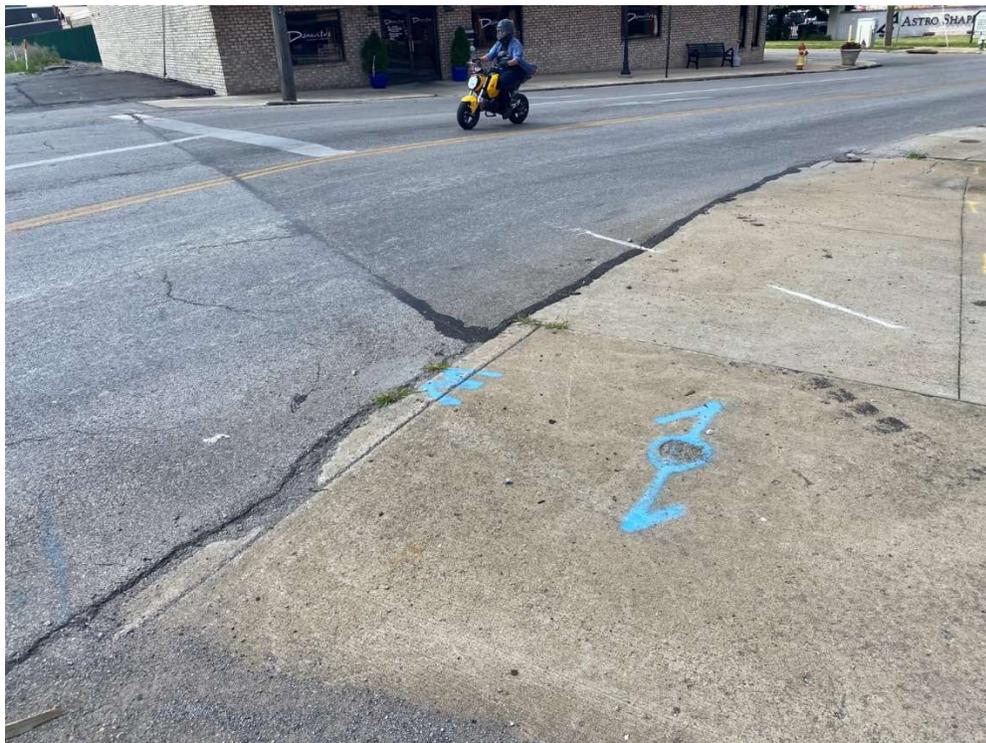
Figure 13 - Curb flush with the roadway at the inside of the curve, east side of South Bridge Street, north of the railroad.

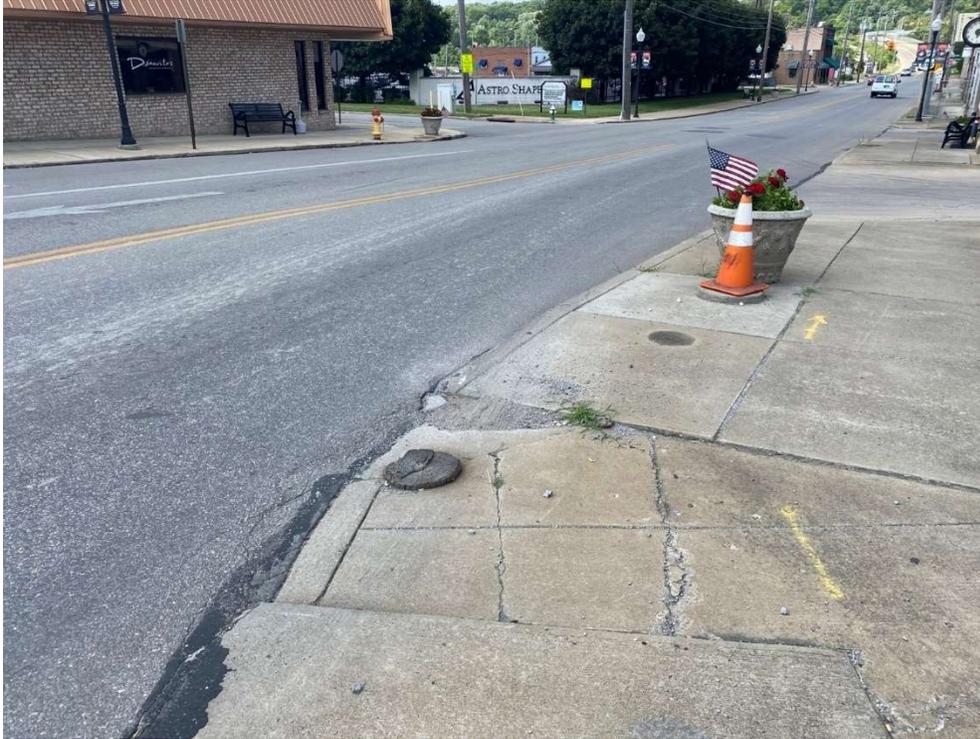
Figure 14 - Inside of curve, east side of South Bridge Street with cut-off pole and tire marks over the edge.

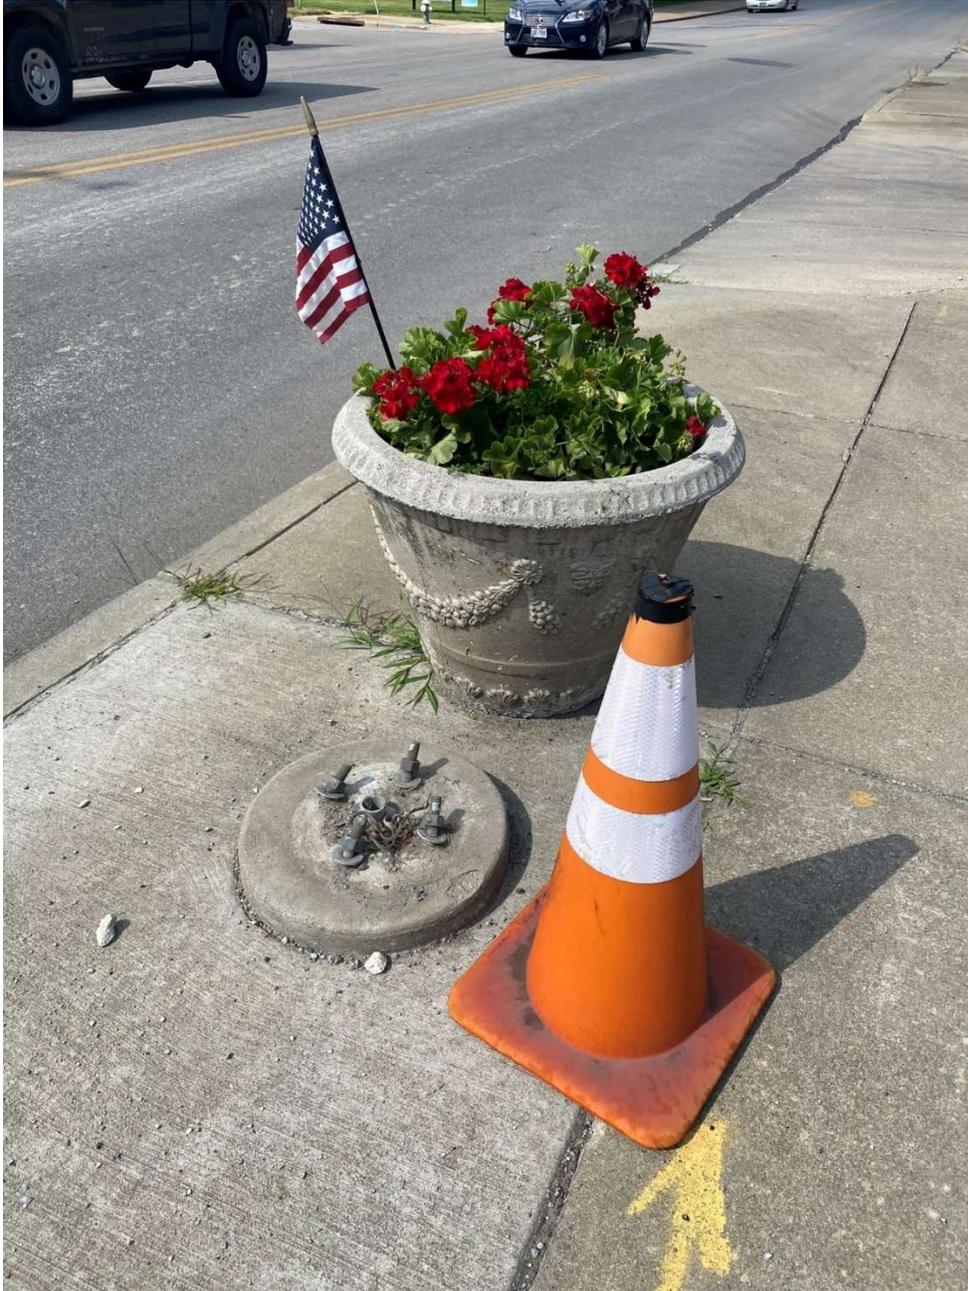
Figure 15 - Pedestal without a pole, normally covered by an orange cone.

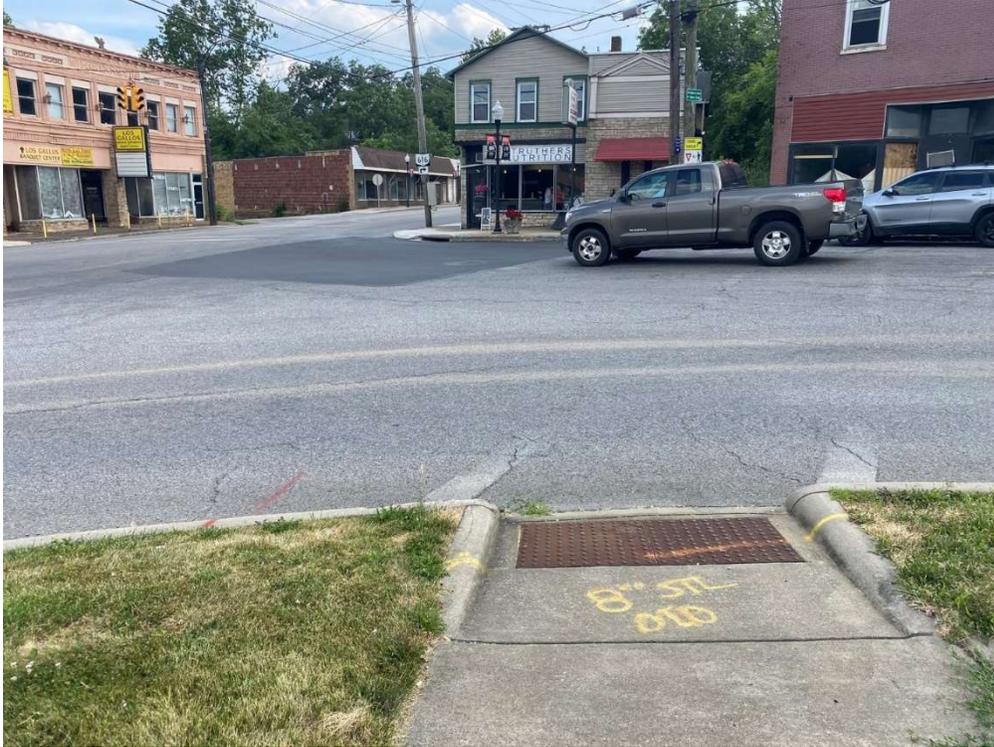
Many of the pavement markings such as arrows and perhaps crosswalk lines were faded or no longer present. There are several locations where lane assignment signs would have been expected, but none were posted.

Figure 17 - Faded crosswalk markings.

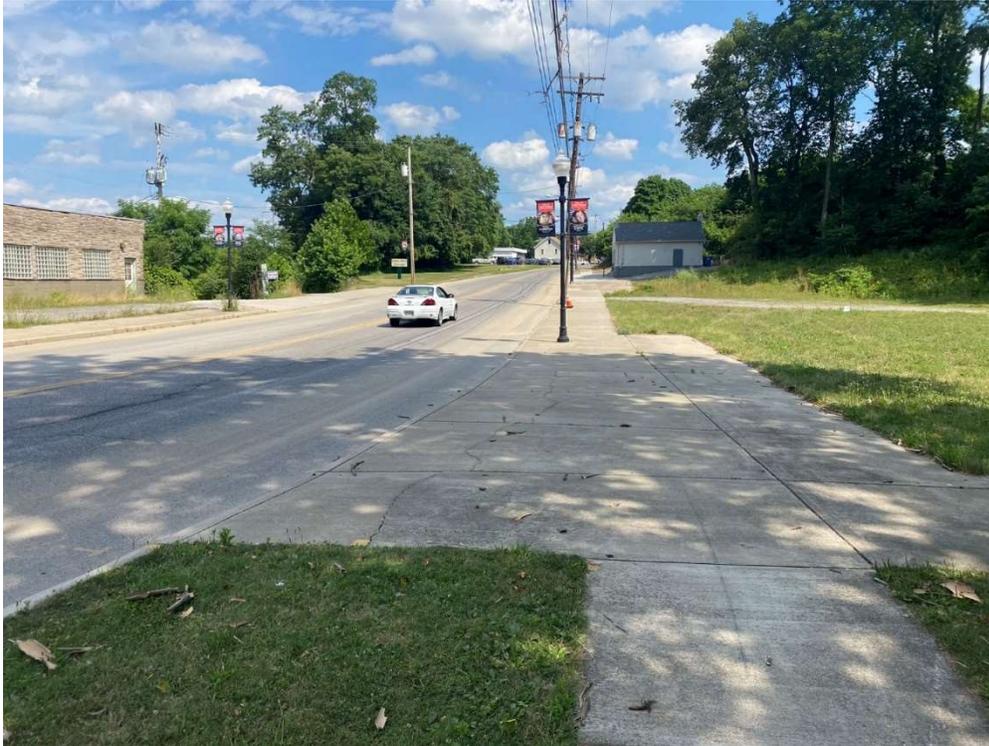
Figure 20 - View of Lowellville Road southbound at South Bridge Street. Example of wide lanes.

The resulting wide lanes can trigger unsafe driving behavior such as passing other vehicles within the same lane and driving faster. This leads to greater opportunities for frustrated drivers to attempt to reduce their waiting times. In a paper titled *Narrower Lanes, Safer Streets*, presented at the 2015 Canadian Institute of Traffic Engineers annual conference, author Dewan Masud Karim provides evidence that wider lanes increase risk on city streets. Karim conducted a wide-ranging review of existing research as well as an examination of crash databases in two cities, which focused on 190 randomly selected intersections in Tokyo and 70 in Toronto. Karim found that collision rates rise as lane widths exceed about 10.5 feet.

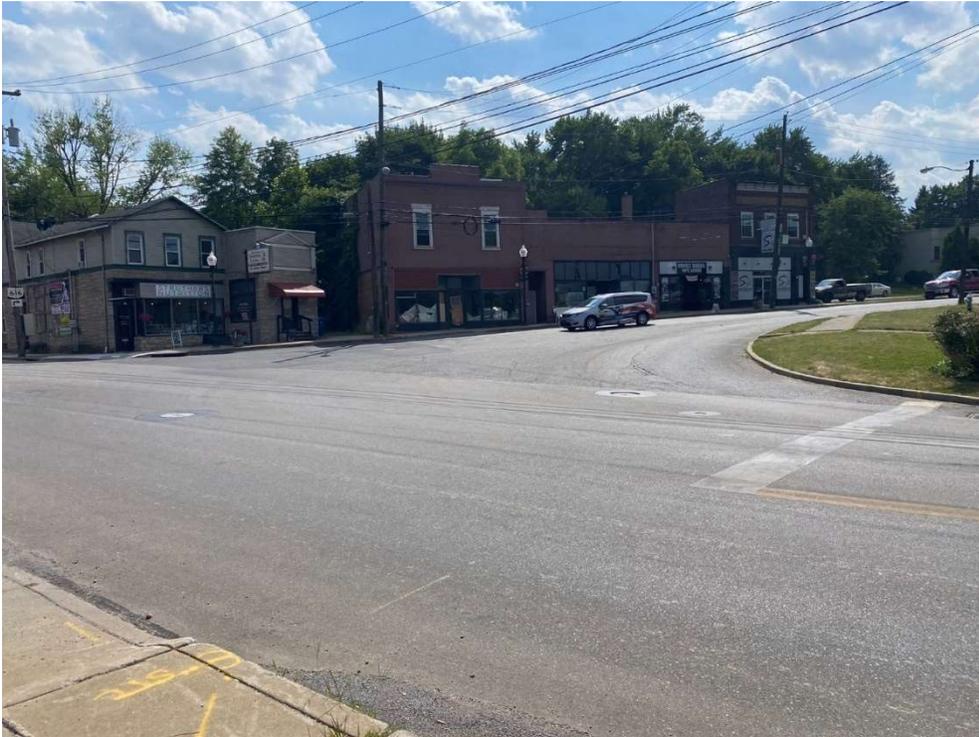
Figure 22 - Large curb return at State Street.

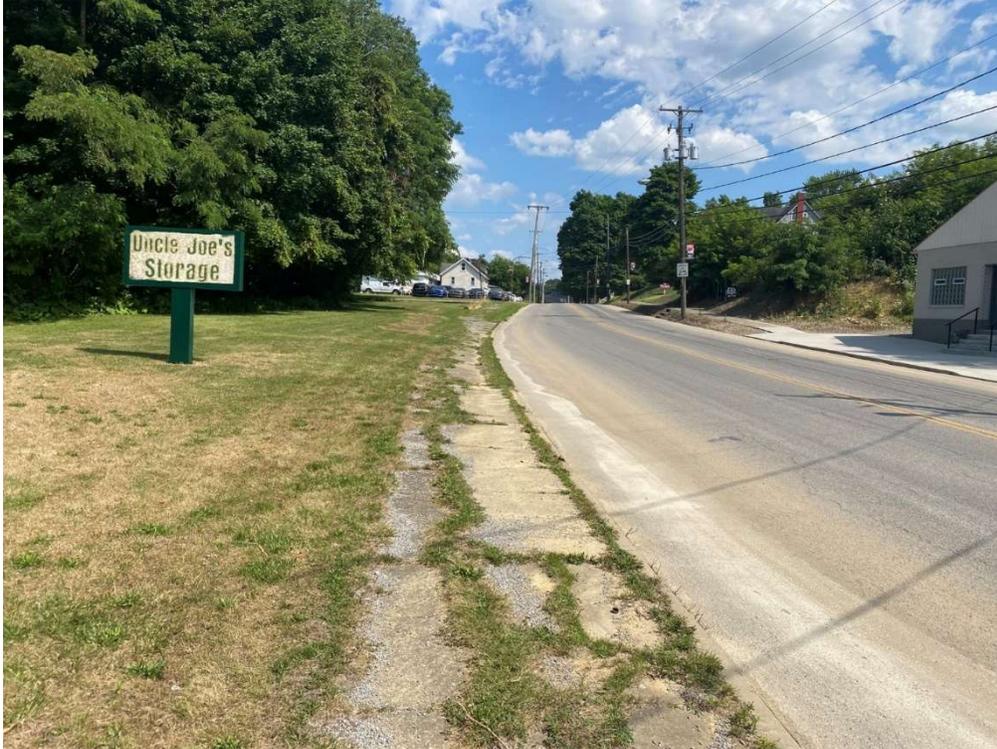
Figure 23 - Insufficient pedestrian facility south of South Bridge Street, east side of Lowellville Road.

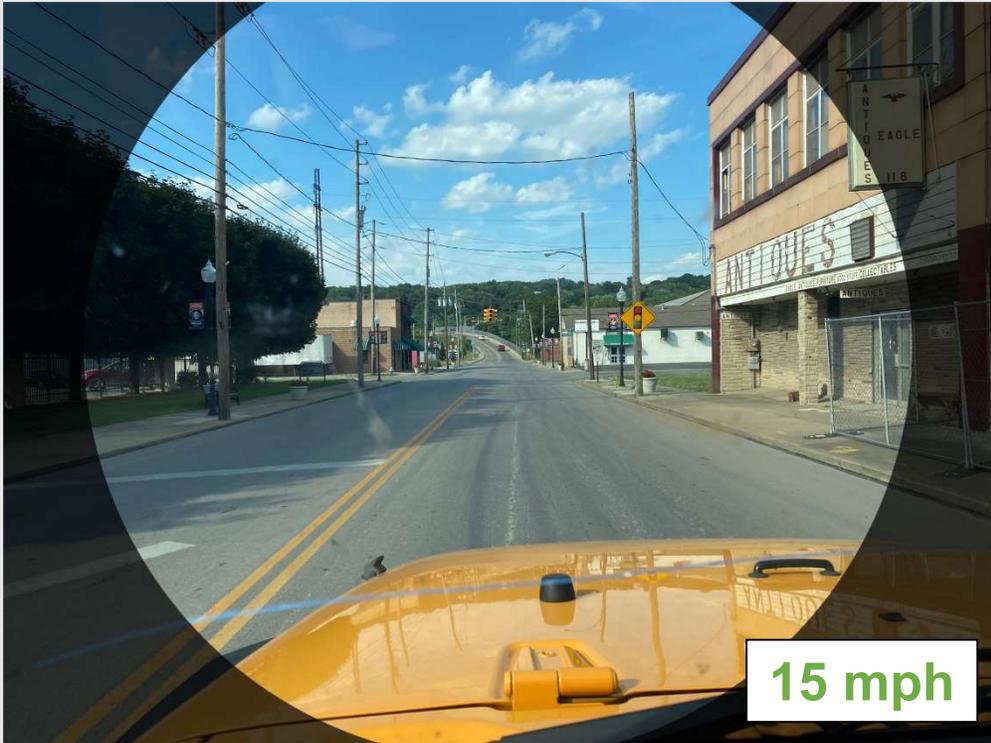
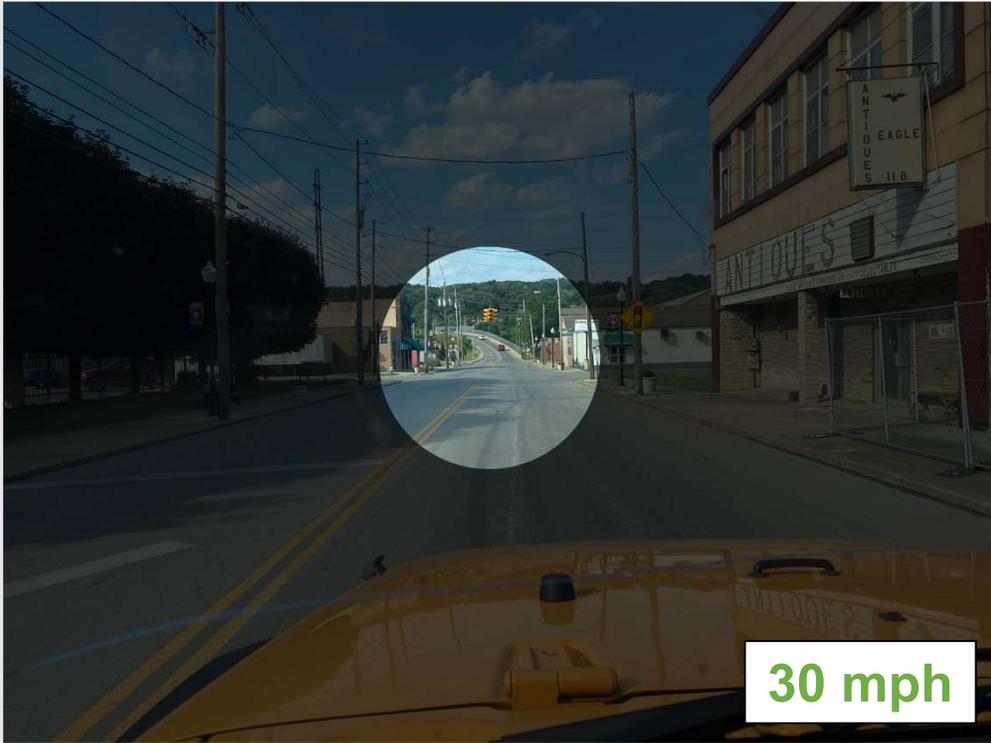
The visibility of the signal is less than desirable. There is only one signal serving the entire intersection, hanging in the center. The signal head is small and not especially noticeable against the background when northbound or southbound. The W3-3 “signal ahead” signage is placed only 160 feet ahead of the stop northbound and 185 feet ahead of the stop southbound, which does not provide enough time and space for a driver to perceive, make a decision, and react. The signs are also set on the outside edge of the driver’s cone of vision due to the wide lanes. See Figure 35 for a representation of the poor visibility of the signal and advisory signage.

Figure 35 – Poor visibility northbound on S. Bridge Street.

- Remove the singular signals at State Street and Liberty Street and replace with new, 12" signal heads with back plates. Install two signal heads per approach. Use ODOT standard mast arms and remove excess wiring.

- Install advisory signage such as W3-3 "Signal Ahead" at OMUTCD recommended distances in advance of the intersections.
- Install lane assignment signage (R3-5L, R3-8) and Left Turn Yield on Green (R10-12) signage on approaches and overhead.
