Bridge Street and State Street Intersections Safety Study

Safety Study
Prepared for: City of Struthers
September 2022

City of Struthers, Ohio
Mahoning County
Intersection: Bridge Street and Lowellville Road,
Bridge Street and State Street, and Bridge
Street and Terrace Street
Study Completion Date: September 2022
Consultant: Environmental Design Group

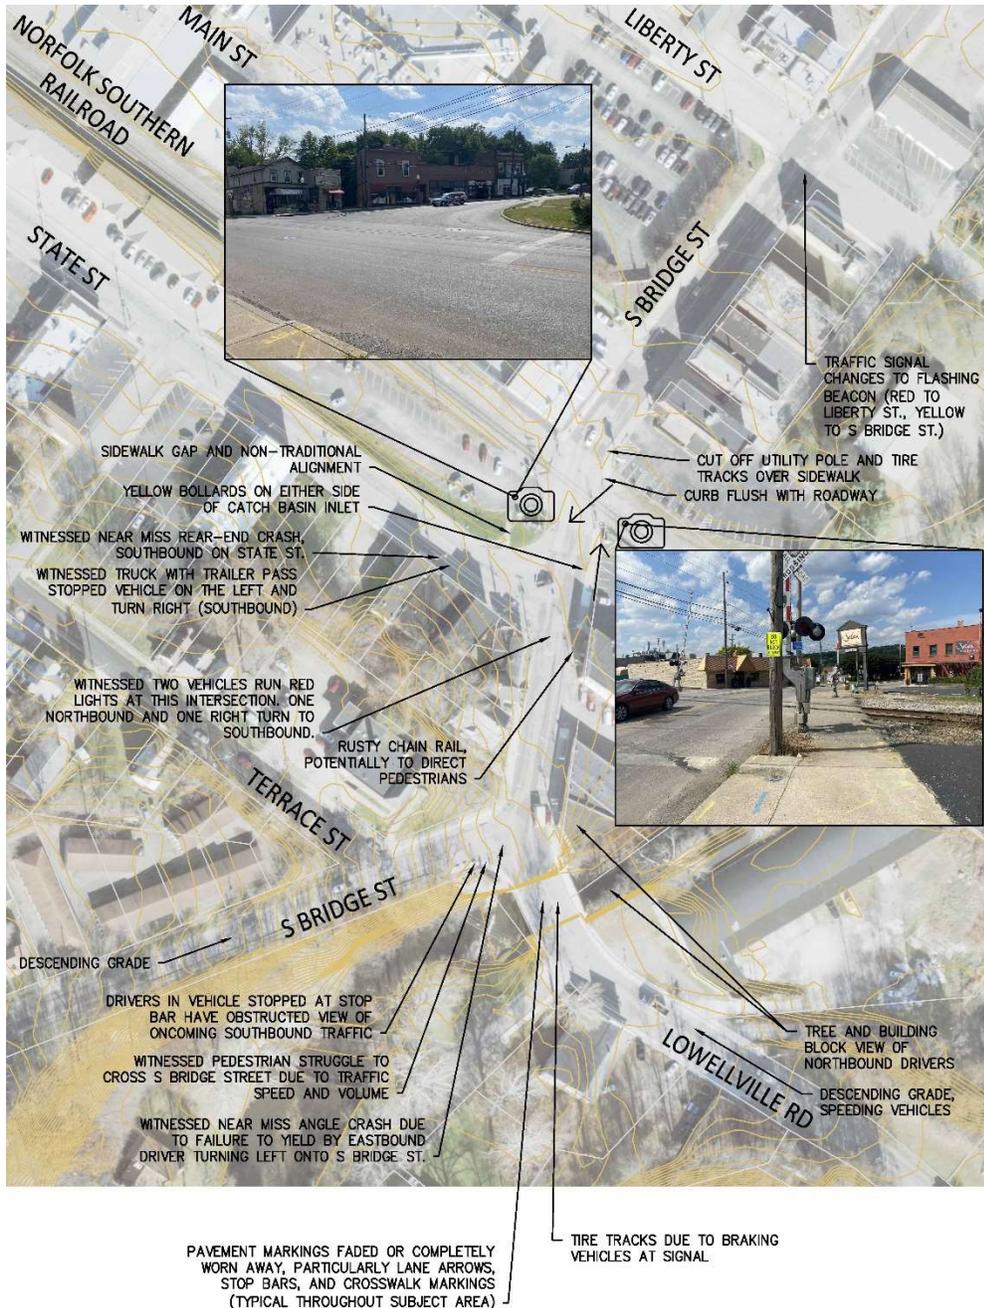
Figure 4 – Existing conditions within the study area.

information is supplemented with other sources of information from the City of Struthers, ODOT, and Google Earth imaging. The observations and current conditions are described below as visually articulated in Figure 4. The existing traffic control is depicted in Figure 5. Full sheets are in Appendix A.

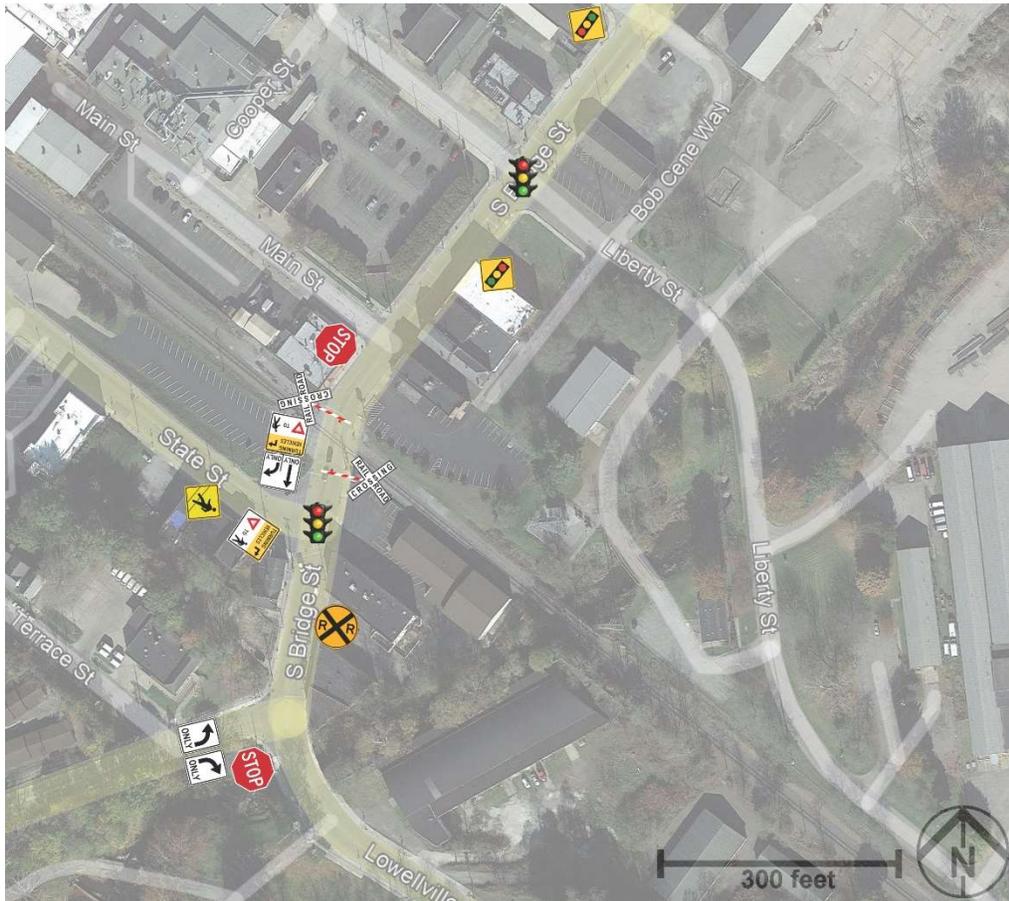
Figure 5 - Existing signage and traffic control within the study area.

Various traffic controls exist throughout the area, including level crossing signals at the railroad (for both vehicular traffic and pedestrian traffic), two traffic signals, and two stop-controlled intersections. See Figure 5 for a diagram showing these traffic controls. The posted speed limit throughout the subject area is 25mph.

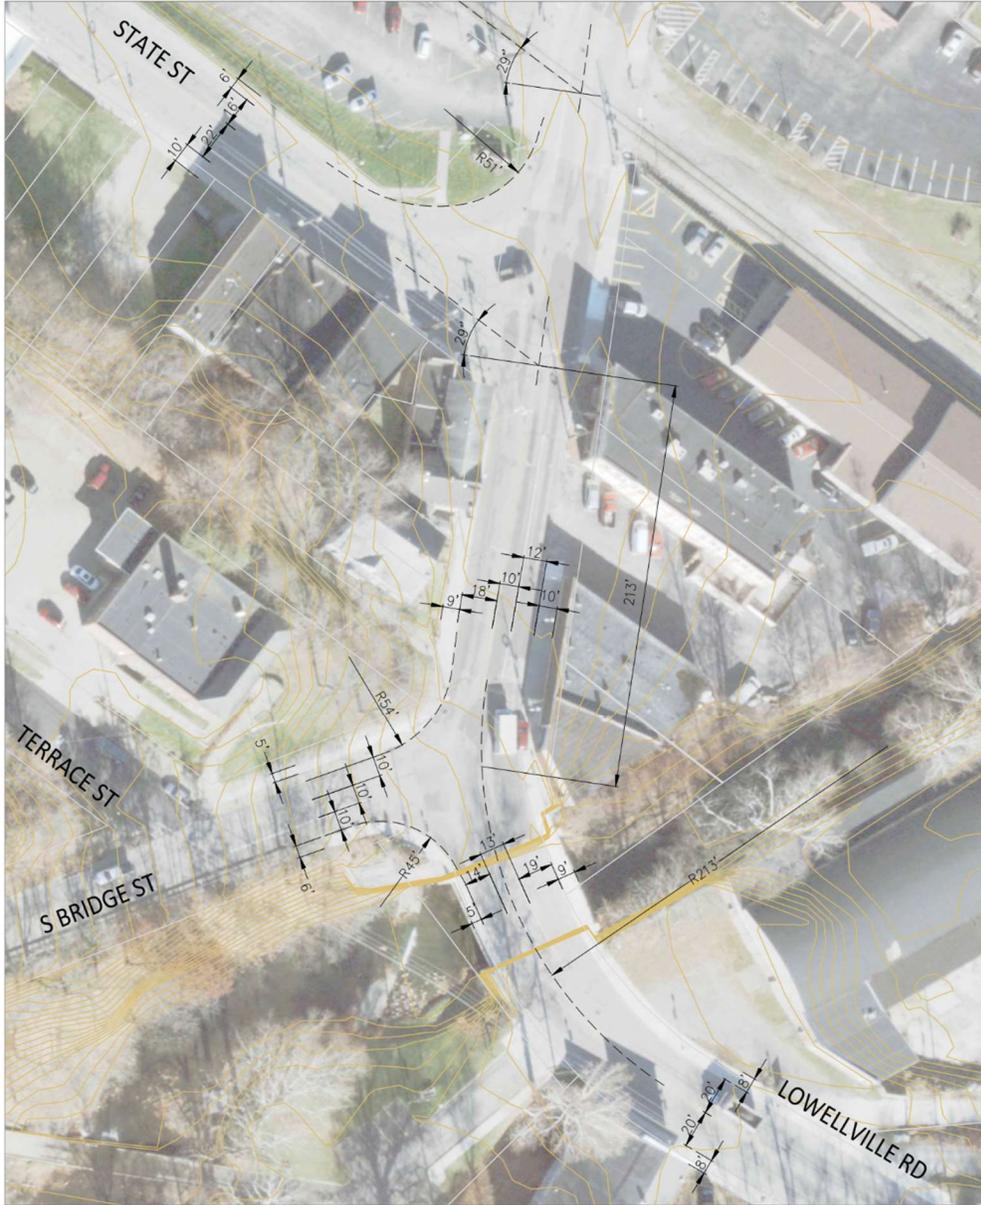
Figure 6 - Facility dimensions, the southern portion of South Bridge Street.

The roadway and sidewalk dimensions vary throughout the subject area and are articulated in Figure 6 and Figure 7. The two curves on South Bridge Street have approximated radii of 149 feet and 213 feet. The lane widths vary throughout the area from 10 feet to 20 feet. Similarly, the width of the sidewalk varies from 5 feet to 10 feet. In some cases, the wide exterior lanes are assumed to include street parking, although minimal street parking was observed during the site review. The curb returns at the intersections of State Street and South Bridge Street with South Bridge Street are relatively large,

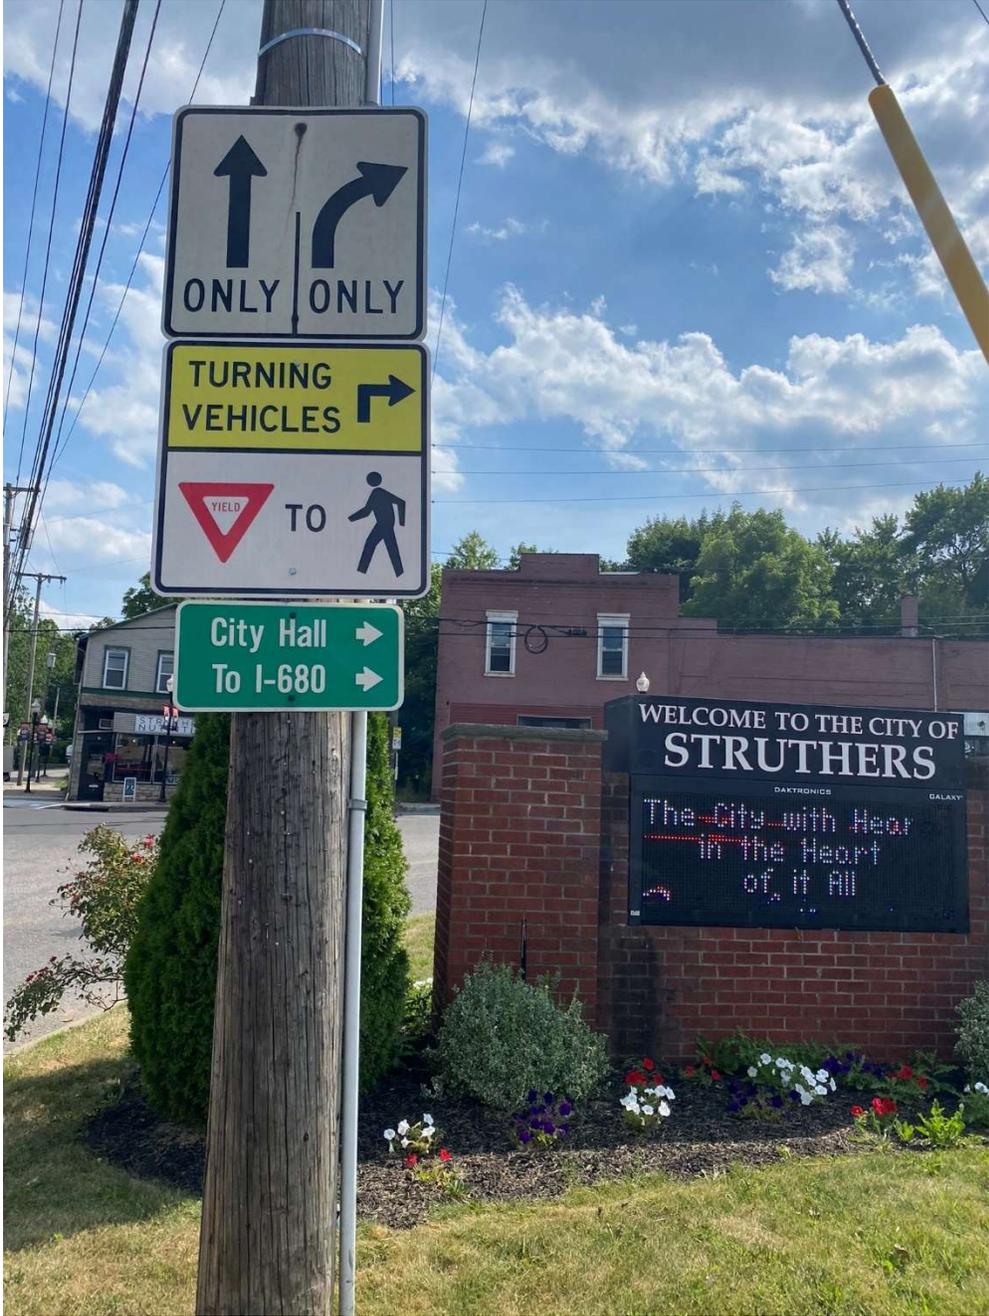
Figure 16 - R10-15 pedestrian crossing signage.

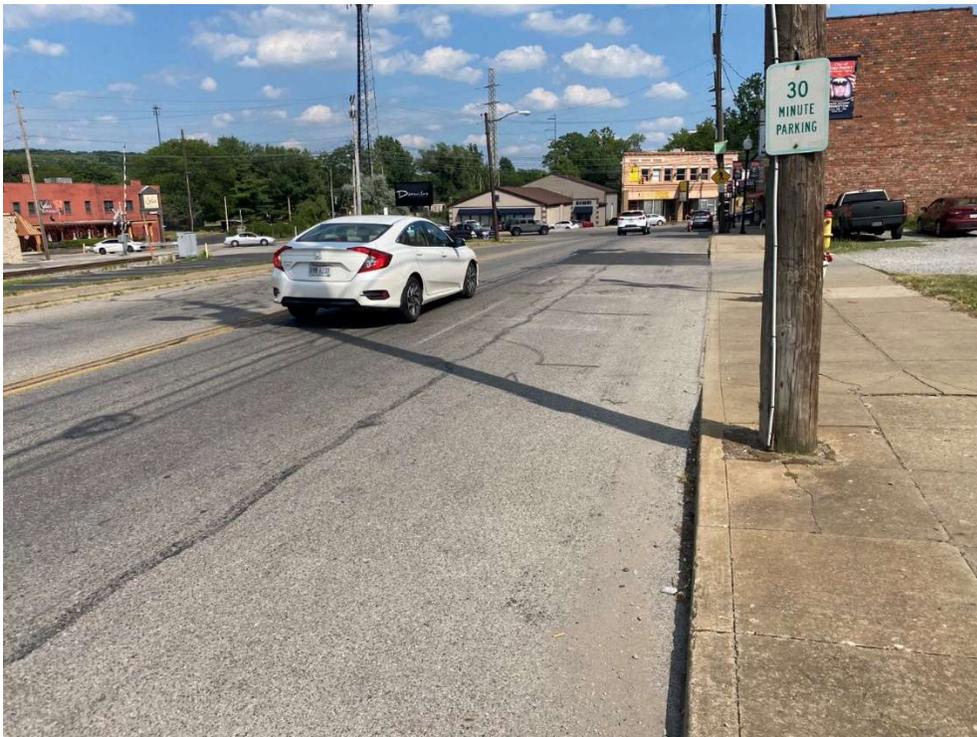
Figure 18 - View of South Bridge Street intersection from State Street eastbound.

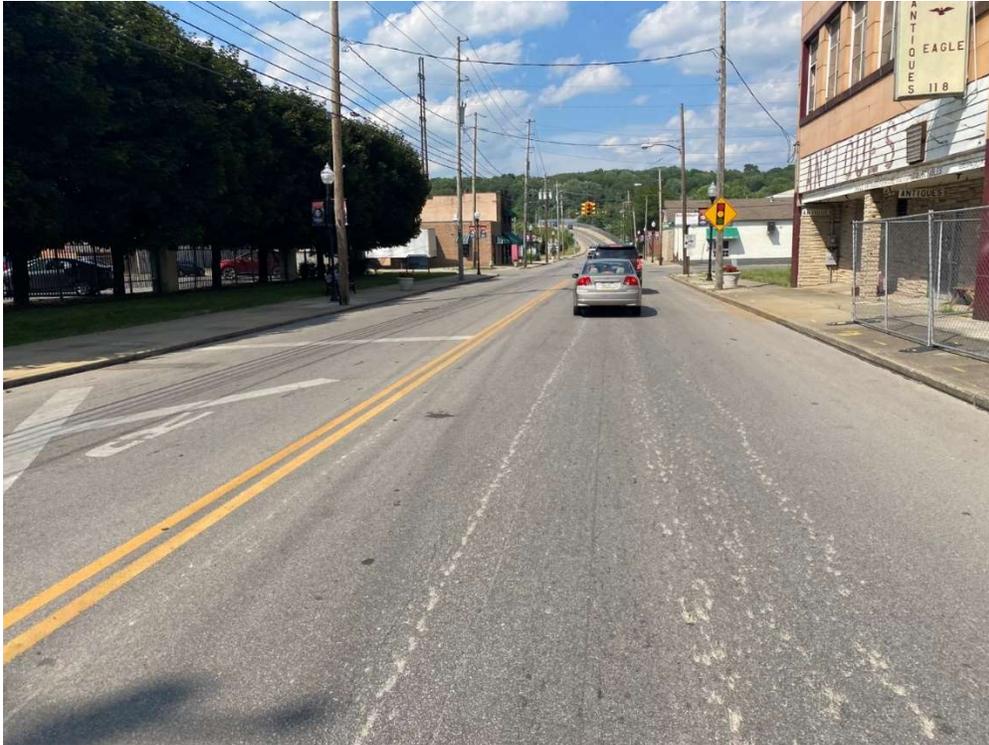
Figure 19 - View of Liberty Street intersection from South Bridge Street northbound.

The signal at Bridge Street and Liberty Street has been in place for only five years. Previously, Bridge Street was not stop-controlled. Residents, employees, and other people that have driven this area for longer than five years may fail to recognize or remember that the intersection is now signalized. In fact, a police officer confirmed that many of the drivers cited for Ran Red Light stated that they forgot about the signal or did not notice the red light. Drivers do not anticipate the potential need to stop.

The signal is not always on a red-green phase cycle. During the field review, it was noted that the signal switched to a flashing beacon style operation, with Bridge Street traffic receiving the yellow and Liberty Street with the red. This setting favors the north/south traffic on Bridge Street which is significantly higher than that of Liberty Street, however, it causes drivers to not expect a stop at the intersection. This results in more Ran Red Light actions and also increases the likelihood of Rear End crashes as drivers are “surprised” by the direction to stop. Drivers do not anticipate the potential need to stop.

The visibility of the signal is less than desirable. There is only one signal serving the entire intersection, hanging in the center. The signal head is small and not especially noticeable against the background when northbound or southbound. The W3-3 “signal ahead” signage is placed only 160 feet ahead of the stop northbound and 185 feet ahead of the stop southbound, which does not provide enough time and space for a driver to perceive, make a decision, and react. The signs are also set on the outside edge of the driver’s cone of vision due to the wide lanes. See Figure 35 for a representation of the poor visibility of the signal and advisory signage.

- Remove the singular signals at State Street and Liberty Street and replace with new, 12" signal heads with back plates. Install two signal heads per approach. Use ODOT standard mast arms and remove excess wiring.

- Remove the flashing beacon phase of the signal(s). Install detectors at the minor approaches to better facilitate traffic for all approaches.
- Optimize the signal phasing at all signals.

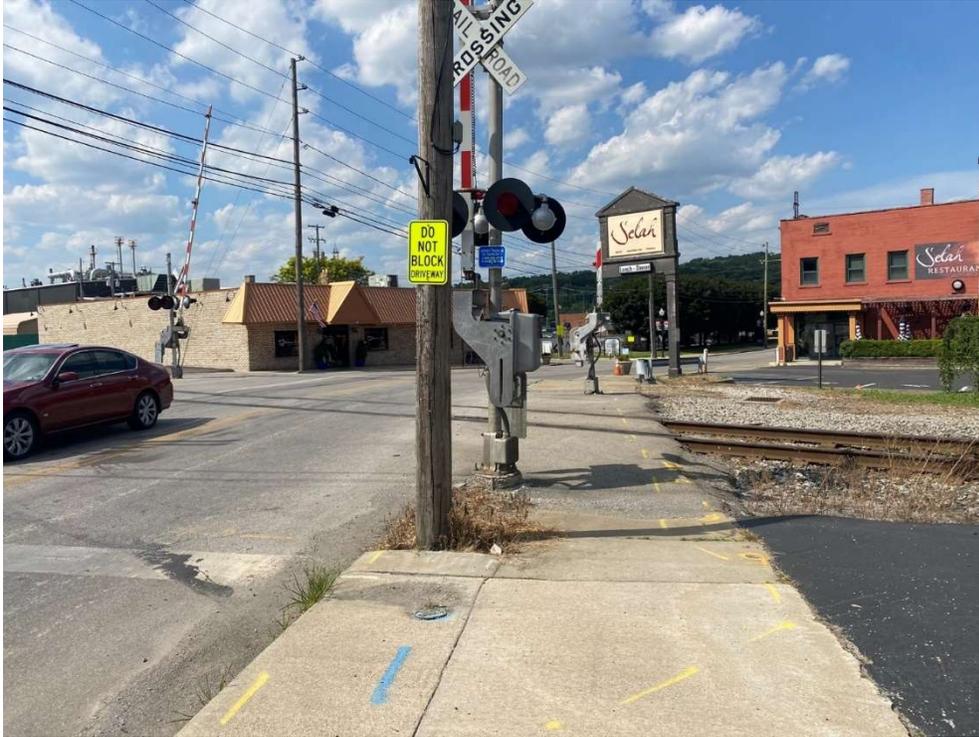
Figure 21 - Rail crossing with pedestrian and vehicular protection.

The Norfolk Southern rail crossing Bridge Street at the center of town often causes long queues and delays throughout the area. Queues develop on Bridge Street eastbound at the Lowellville Road intersection and also on State Street eastbound at the Bridge Street intersection. When the train has passed and the roadway is opened, some drivers must wait several minutes before they can proceed through the intersection which they were approaching.

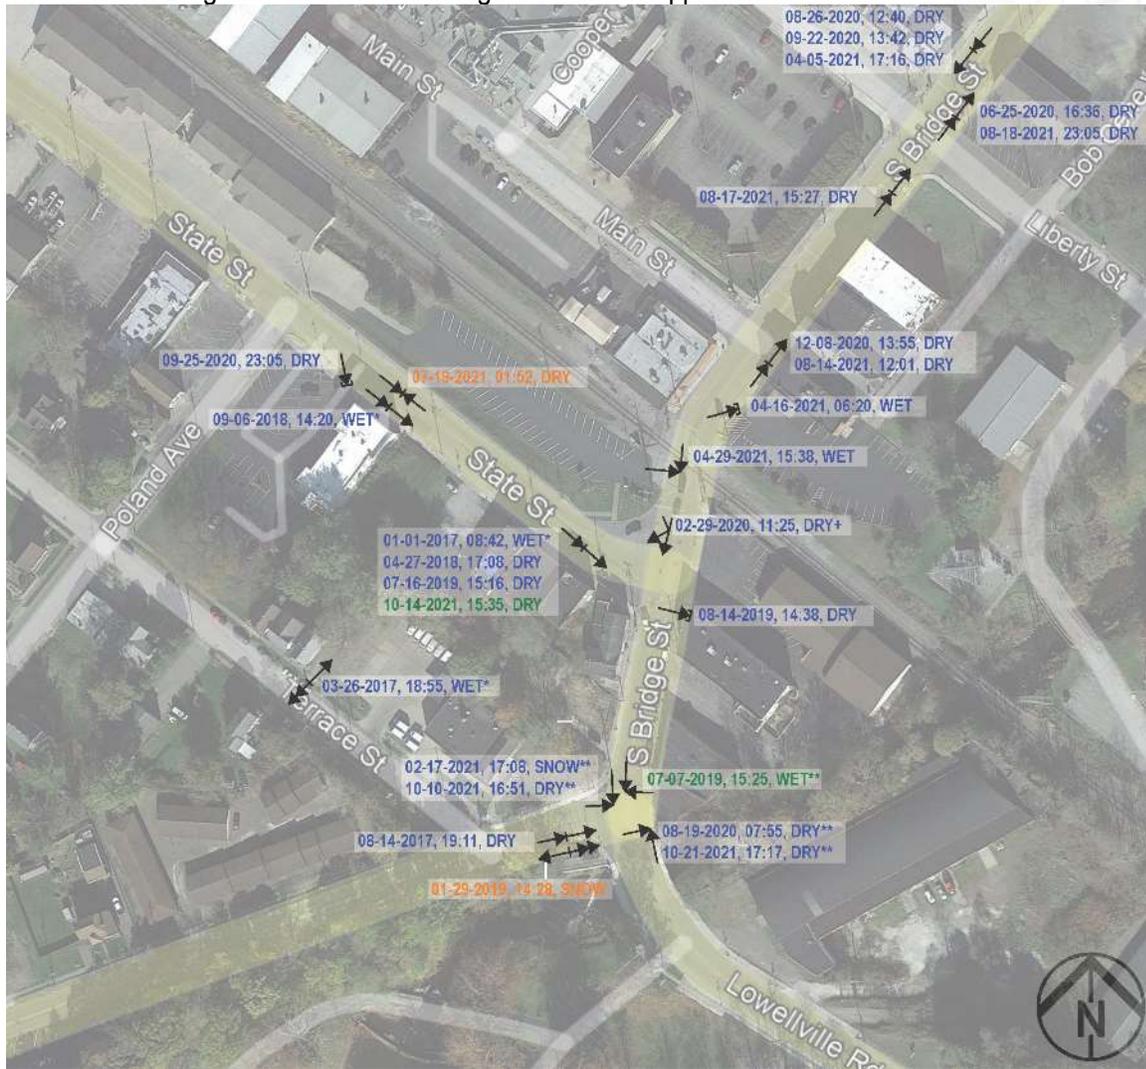
Figure 33 – Crash Diagram for study years 2017 – 2021.

- Six crashes (27%) occurred at the intersection of South Bridge Street and Lowellville Road and five were angle crashes due to Failure to Yield. One was a backing crash due to Improper Backing.

- Four crashes (18%) occurred at the intersection of South Bridge Street and State Street. Two were rear end crashes due to Following Too Closely / Assured Clear Distance Ahead, one was a sideswipe-passing crash due to Improper Passing, and one was a fixed object crash due to Improper Turn.

- * DRIVER HIT PARKED CAR
- ** FAILURE TO YIELD
- + IMPROPER PASSING ON RIGHT
